Aeration Fountains in Lake Merritt

Save The Bay Tours Lake Merritt's Waste Technology

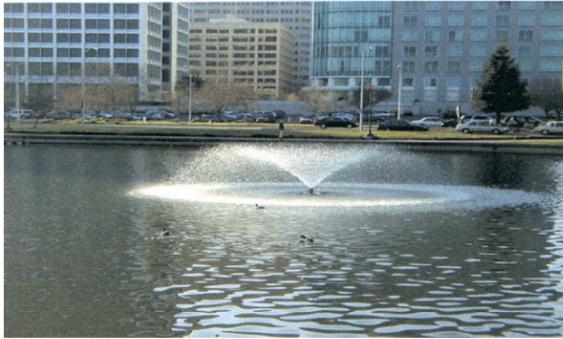
Glen Echo Fountain

Aeration Fountains continued...

has been cleaned recently from the aeration fountains.

Bandstand Cove, the E. 18th Street Pier and the Glen Echo Arm. They are lit from dusk to midnight. The Lake Merritt Institute installed two units (E.18th Street Fountain and Bandstand Beach Fountain) in 2003 with the help of donor contributions. These fountains incorporate several new design features and improvements. The Glen Echo Fountain, installed with the help of grant funds, has been extensively renovated, but is of an outdated design and subject to frequent clogging. The Embarcadero Fountain is designed for maximum aeration and is located at the confluence of the Lake's three largest storm drain outfalls. This fountain brings oxygen to the water to compensate for the decay of leaves and other organic matter from these storm drains.

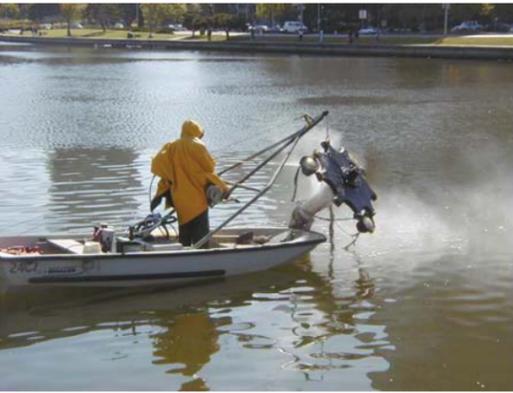
Cleanup of aeration fountains after winter

The Lake Merritt Institute provides maintenance to keep the fountains clean and in operating condition. Maintenance includes frequent power washing to remove barnacles, mussels and tubeworms. The accumulation of barnacle growth

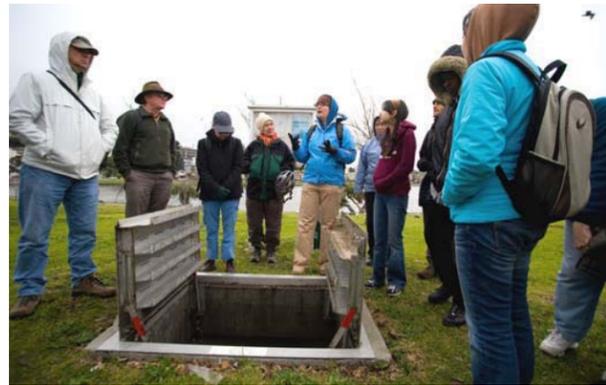
The group clustered around the vortex separator
Photo provided by www.dansullivanimages.com

On what was described by Honore as a very wet and very cold day, the group observed the method in which one of four storm drain separators operates. Resembling a colander, the device takes the storm drain flow and spins it through a cylinder, which separates the trash and prevents it from flowing into the Lake. Dr. Bailey provided the group with a bird's-eye view of the operation by opening a trapdoor on the storm drain separator.
